# Repair Work to Bykle Kyrkje

July 1, 2001

## Appendix 1 - Numbering for Panels

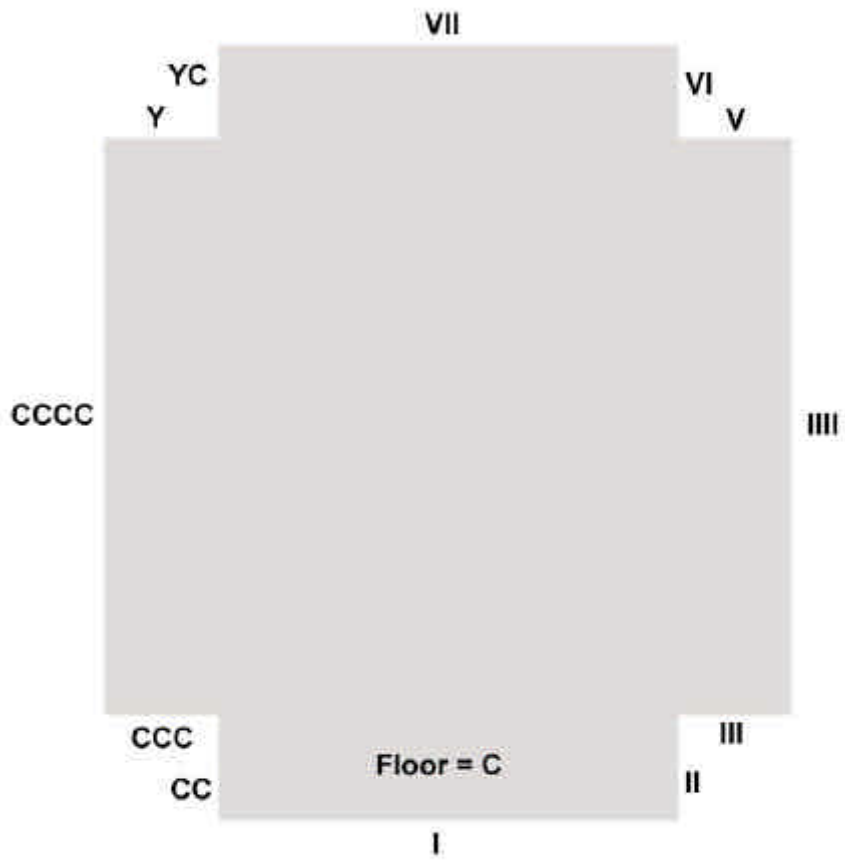
All panels are numbered: Left, 1, 2, 3, ... 9, 10, 11, Right
