Restoring Bykle Kyrkje 2001/2002

Final Report

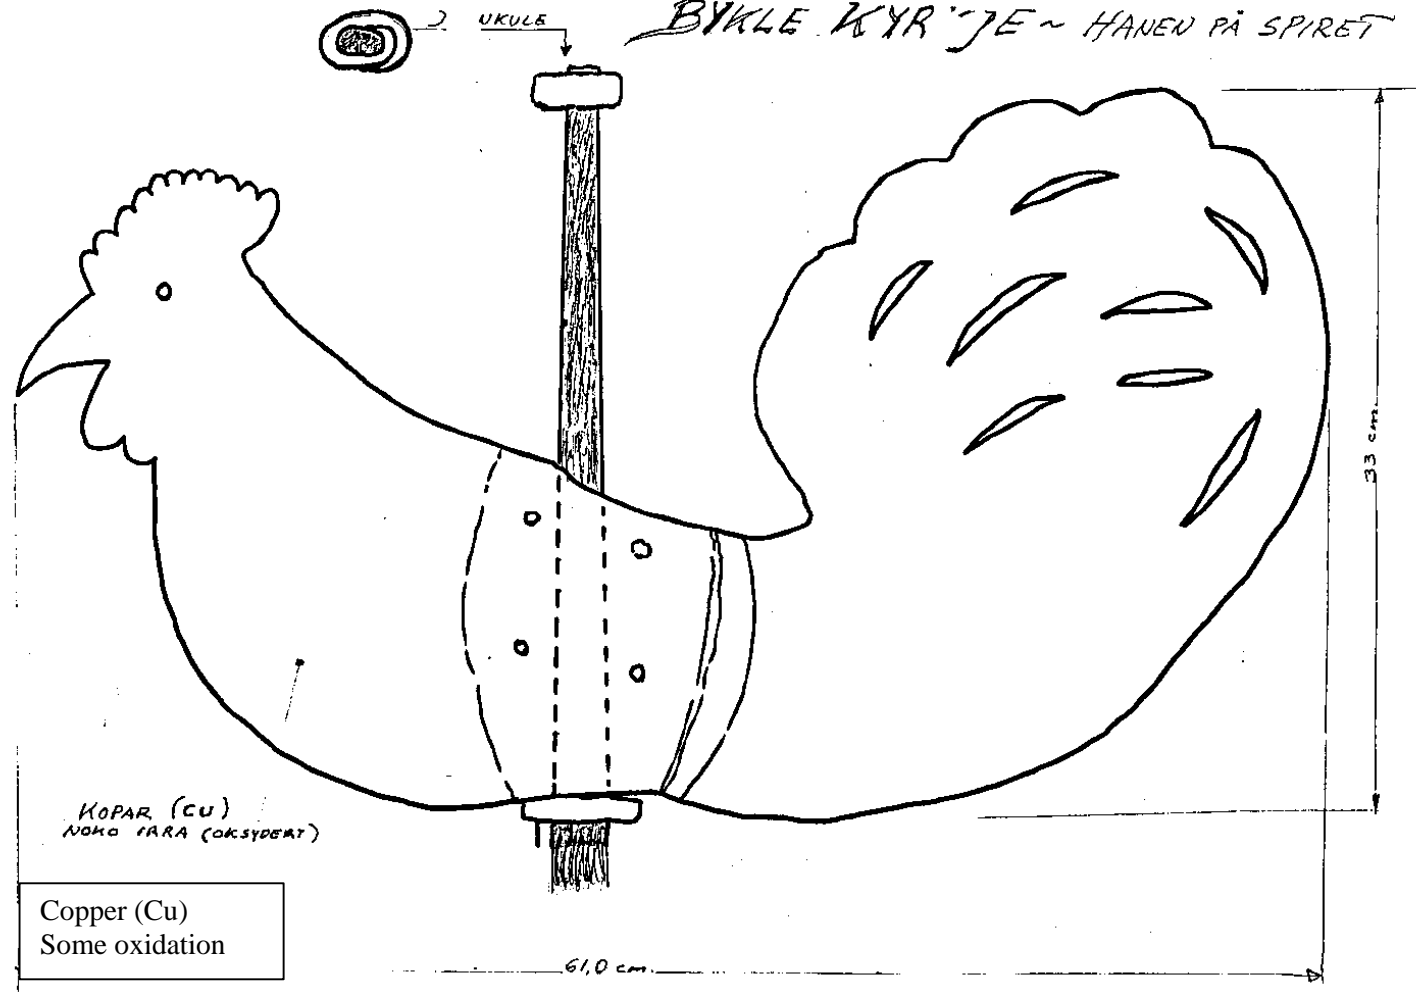
BYKLE KYR'JE ~ HANEN PÅ SPIRET

Copper (Cu)
Some oxidation

Sink or other metal - rivetted

Slightly loose fit

Crack

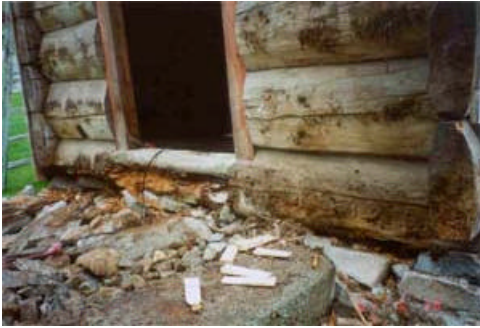
1. Entrance vestibule: The door sill had extensive rot damage.

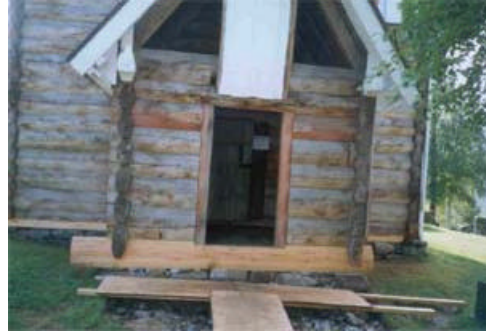
2. Entrance vestibule: Reconstructed the sill and joined it in place.

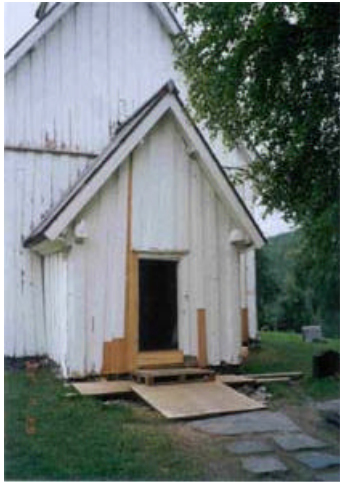
3. Entrance vestibule: Installed external panels. Photos shows that new materials were used.

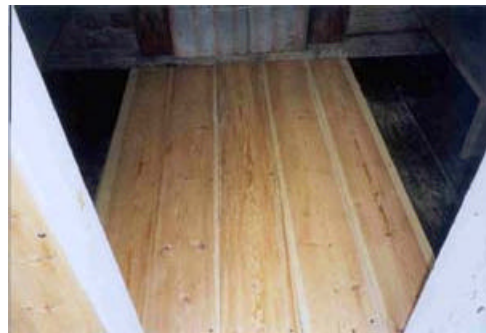
4. Entrance vestibule: Three joists and five floor boards were reconstructed.

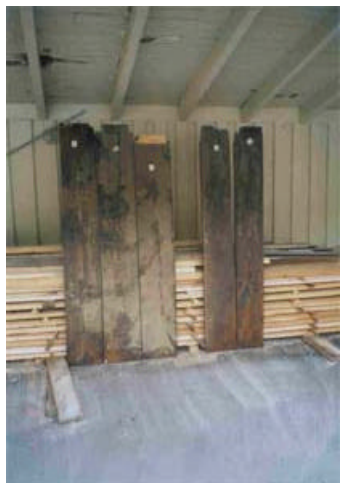
5. Entrance vestibule: Photo number 5 shows the new floor boards, the old ones had been replaced earlier.

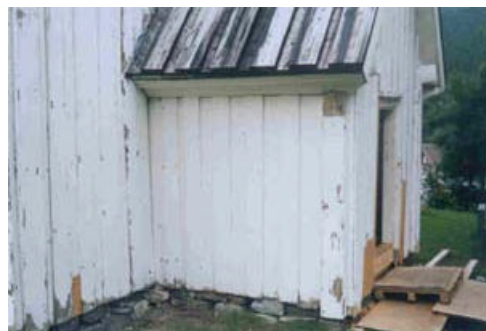
The corner panel was lowered due to rot damage in the lower parts (see ground plan, Addey-Jibb) 6.

6. Entrance vestibule: Wall CC. The corner panel was lowered due to rot damage in the lower parts.

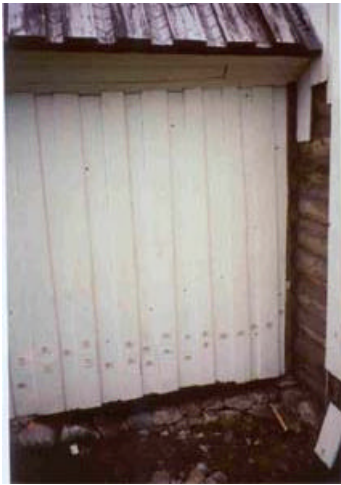
7. Entrance vestibule: Wall II was scraped and painted.

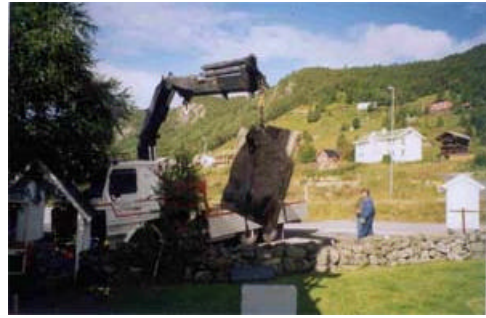
8. Stairs: The flagstone in front of the door is the original, the flagstones lie in crushed rock.

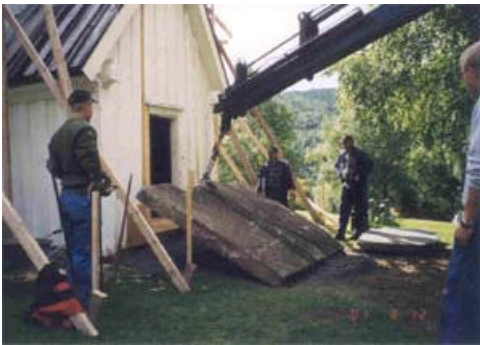
9. Stairs: The flagstone in front of the door is the original, the flagstones lie in crushed rock.

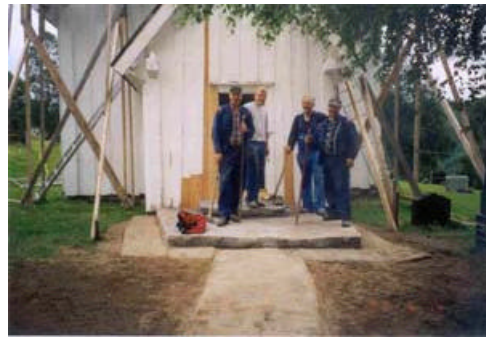
10. Stairs: The flagstone in front of the door is the original, the flagstones lie in crushed rock.

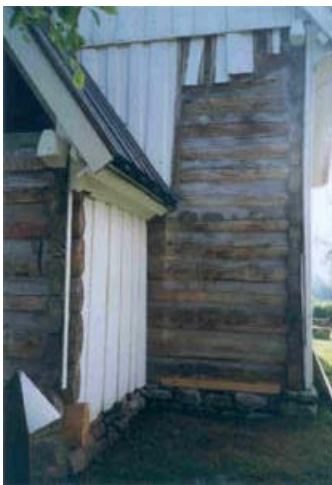
11. Nave Gable - end walls: Wall III. Dismantled external panels.

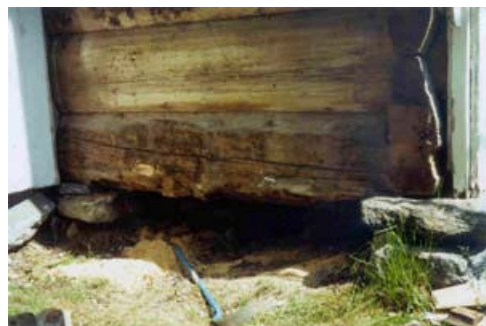
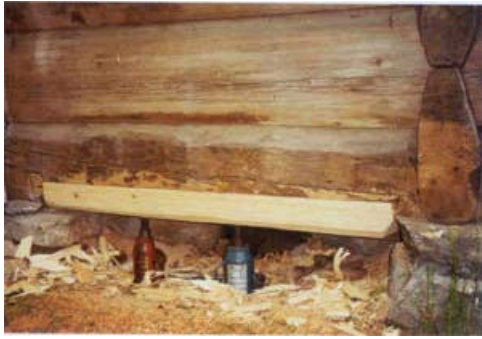
12. Nave Gable - end walls: Wall III. Rot damaged sill was bunged up (inserted) with new wood. The foundation wall was laid in crushed rock.

13. Nave Gable - end walls: Wall III. Rot damaged sill was bunged up (inserted) with new wood. The foundation wall was laid in crushed rock.

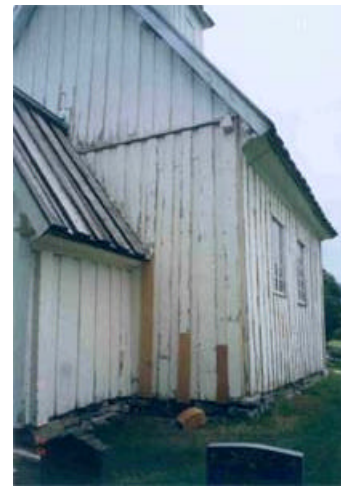
14. Nave Gable - end walls: Wall III. The photo shows the use of new wood materials - scraped and painted.

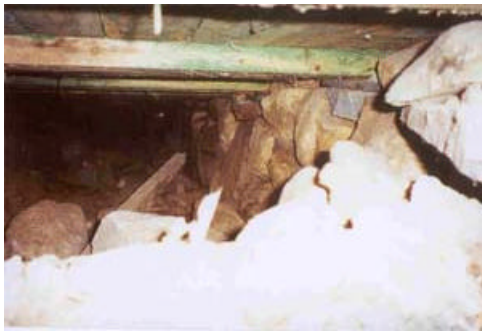
15. Nave Gable - end walls: Wall III. Joists were impregnated against parasites during the last restoration. There is no rot damage on these.

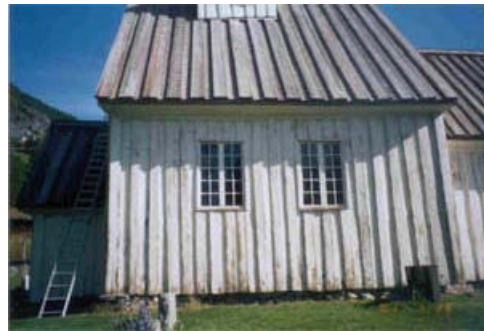
16. Nave Gable - end walls: Wall III. Attached single panels with hand-forged nails. Scraped and painted.

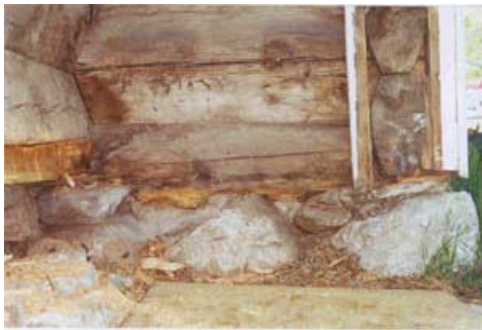
Dismantled external panels. Rot damage was found on sill and corner. 18.
Rot damage was removed and the foundation wall supported. Due to rot damage the wall had settled quite a bit in the corner. Rot damage was removed and supported with a flagstone. We did not attempt to adjust the wall CCC due to the support for the joists. External panels were then replaced, scraped and painted.

18. Nave Gable - end walls: Wall Y. Dismantled external panels. Rot damage was found on sill and corner.

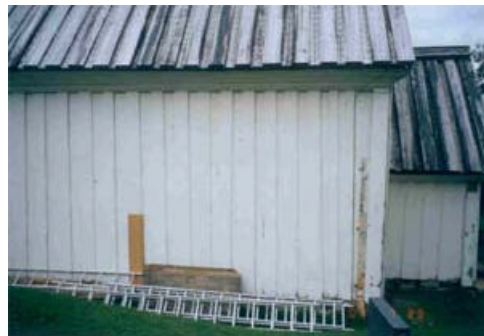
19. Nave Gable - end walls: Scraped and painted Wall CCCC.

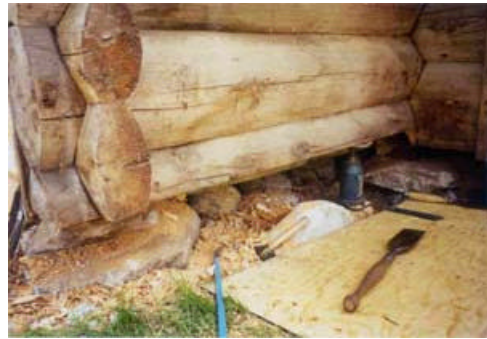
20. Nave Gable - end walls: Wall CCC. Dismantled the foundation wall and external panels. The sill was rot damaged.

21. Nave Gable - end walls: Wall CCC. Dismantled the foundation wall and external panels. The sill was rot damaged.

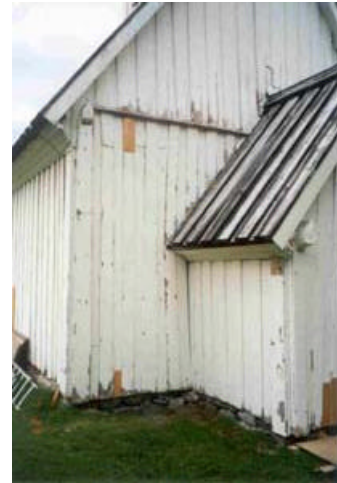
23. Nave Gable - end walls: Wall CCC. External panels were replaced. Photo shows the use of new materials. Scraped and painted.

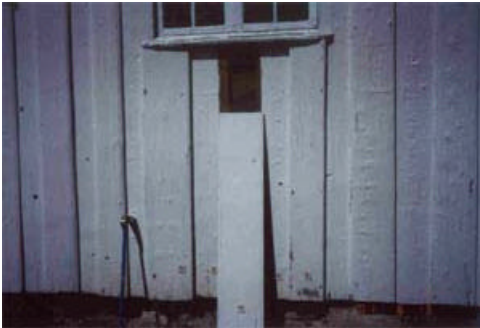
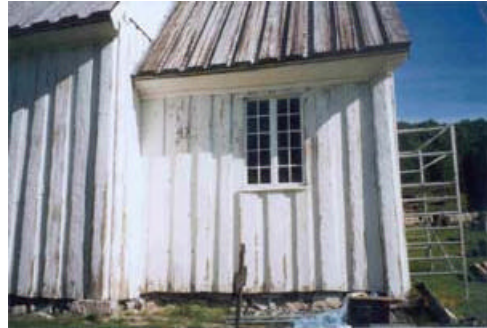
27 og 28. Chancel: Wall VI. Dismantled the foundation wall to examine the joists and floorboards. The joists were lying in dry boggy soil with minor rot damage. The joist foundations were straightened up. The foundation wall was replaced on crushed rock. Scraped and painted.

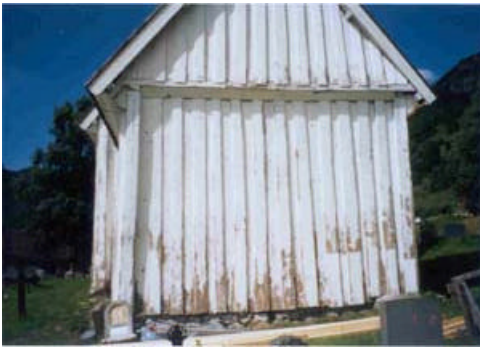
29. Chancel: Wall VIII. Hand-forged nails used to tighten lose panels. Scraped and painted.

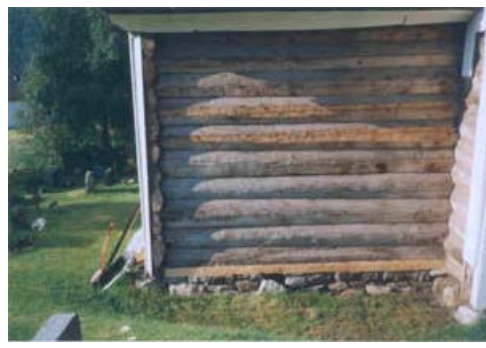
30. Chancel: Wall YC. Dismantled external panels. Bunged up rot damaged sill with new material.

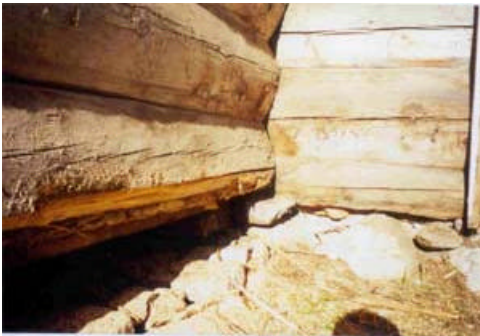
31. Chancel: Wall YC. Rot damaged sill.

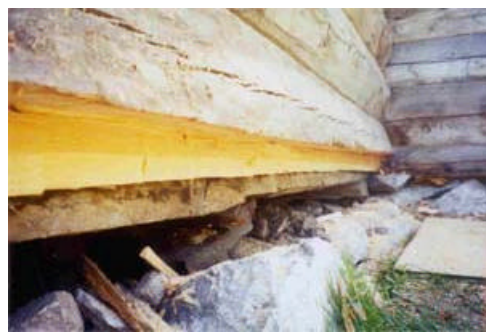
32. Chancel: Wall YC. Rot damaged sill.

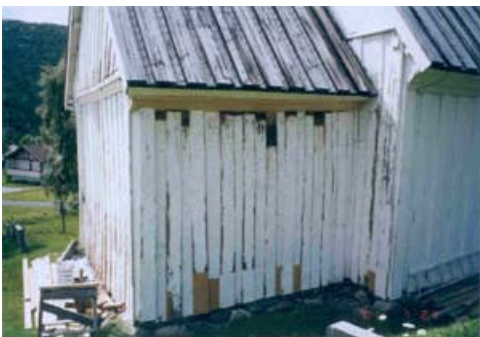
33. Chancel: Wall YC. Photo shows use of new materials. Scraped and painted.

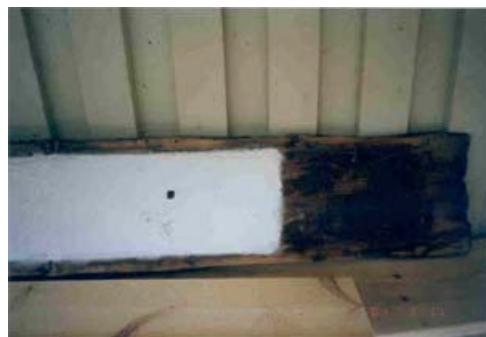
34. Chancel: Wall YC. Photo shows one panel fixed with wooden nails.

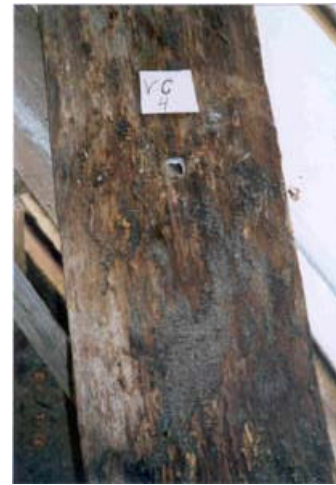
35 og 36. Chancel: Wall YC. Some panels were turned around. There were visible evidence of tar treatment and use of wooden nails.

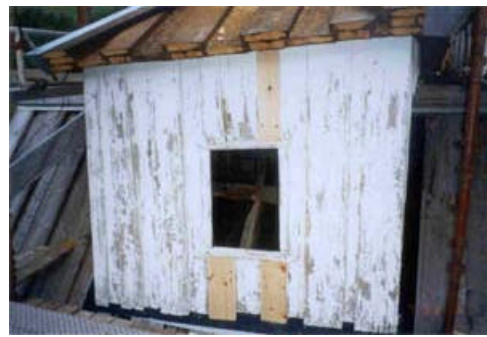
40. Bell tower: The detached scaffolding was built by Ivar Pedersen, Tveit.

41. Bell tower: The church bell tower was scraped and painted. Photo shows use of new materials.

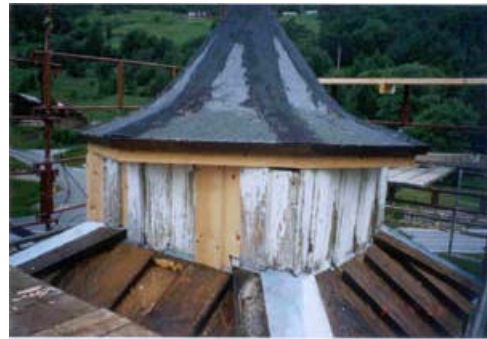
42. Bell tower: The church bell tower was scraped and painted. Photo shows use of new materials.

43. Roof: There was large rot damage on the roof panels. There were no damage to the nailing strip. The ridge of the roof was covered with sink (replaced existing sink). The same pattern for drainage was used as before.

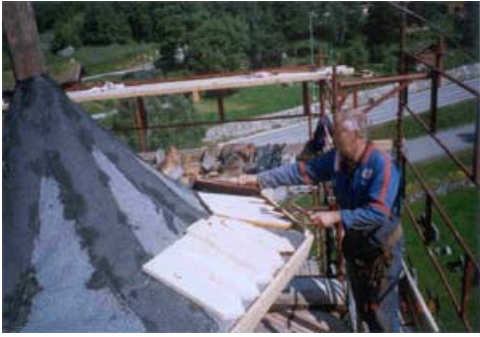
48. Spire: The shingles were shaped with axe and impregnated on all sides with tar prepared in charcoal kiln.

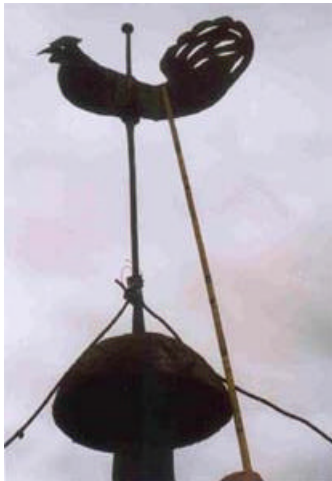
50. Spire: The top row of shingles was reused. See appendix 2 for a sketch of the weathervane.

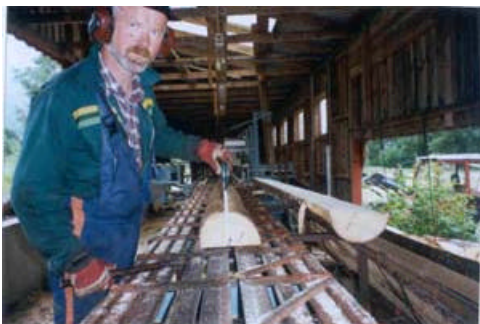
51. New shingles: Standing spruce trees were selected during sap time. The trees had been growing very slowly. The shingles were cut perpendicularly.

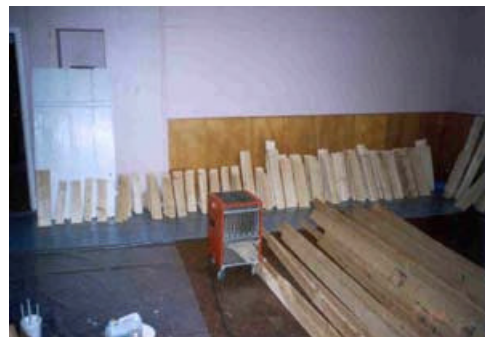
Outer	Inner	
Day 1	23%	15%	
Day 2	23%	11%	
Day 3	17%	8%	
Day 4	11%	8%	
Day 5	11%	10%	
Day 6	installed an electric dehumidifier		
Day 9 (with +25°C temperature)	0%	0%	52.

52. New shingles: The shingles were dried in room temperature (+25°C). Moisture was monitored during the drying period.
