Using iron to maintain and secure old timber buildings in Setesdal

English Translation of the original report in Norwegian:
”Bruk av jern til vedlikehold og sikring av gamle trehus i Setesdal”
Project report for the course ”Videreutdanning i Bygningsvern”
at Høgskolen in Sør-Trøndelag, 2002.

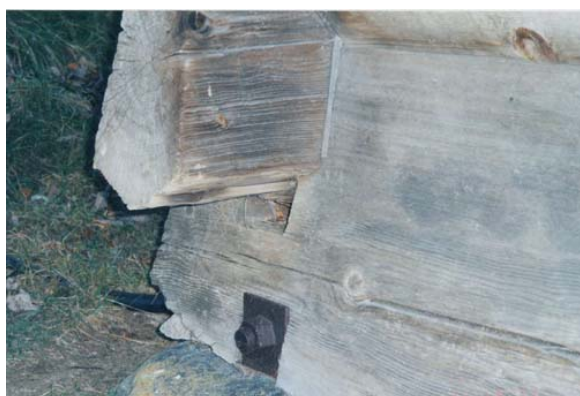
Photo 2.1 and Sketch 2.1 shows the use of a long *gjengestag* to secure a ground sill that has been pushed out. The bar reaches from one side of the building, through the beam to the other side.

Photo 2.1: Securing a pushed out ground sill with a long *gjengestag*, *loft*, Rygnestadtunet, Valle.

Using *gjengestag* to secure buildings is normally a durable solution particularly if the foundations are good and stable. The work shown in Photo 2.1 and Photo 2.2 was done around 1930, and both buildings are as stable now as they were then - over 70 years down the line. The work to secure Rygnestadlopte was performed under the guidance of public authorities because the building is automatically protected due to its age and it is a famous museum. Contrary to this, the work on Nistogslopte was conducted by the owner without financial support because the *loft* is of a more recent date and it was an integral part of the farm and in daily use.

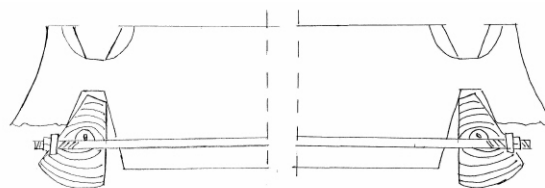
Sketch 2.1: Illustration of securing a pushed out ground sill with a long *gjengestag*, Rygnestadtunet, Valle.

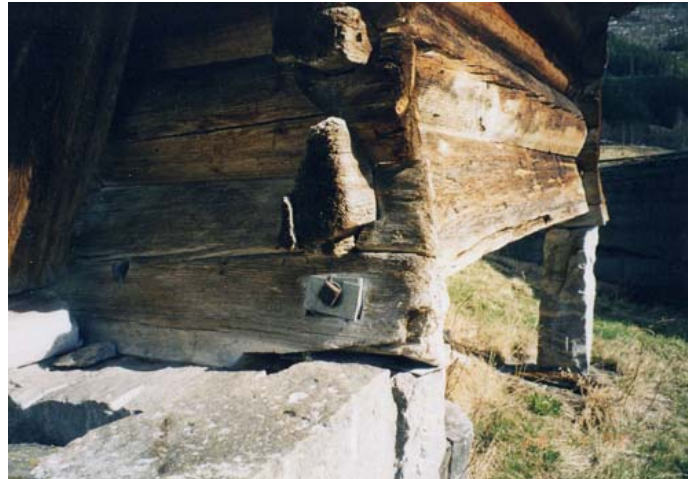
Photo 2.2 and Sketch 2.2 shows how one can use a short *gjengestag* on a pushed out sill. In this case the bar is only inserted through the pushed out sill and a short distance into the side beam where the nut is recessed into the timber. Sketch 2.3 shows another type of short *gjengestag* with a nut at one end and a hook at the other. The *gjengestag* should lie behind the beam and under the floorboards so that one can only see the nut and washer.

Photo 2.2: Securing a pushed out sill with a short *gjengestag*, Nistog Rygnestad, Valle.

The work to secure Rygnestadlopte (Photo 2.2 on page 6) was done both by jacking up the building to straighten up the foundations (called *honsteinane*), and by using two long iron rods or *gjengestag* (one at the front and one at the back). The costs came to around 10.000 kroner (2002 prices). In some cases, where there is no need to jack up the building the costs of using long *gjengestag* can be as low as 1.000-3.000 kroner (for example as was done on Nistogslopte). If instead one used antiquarian methods to secure a pushed-out sill on the *loft* Rygnestadlopte, the costs would have been between 50.000 and 80.000 kroner because one would also have to replace and splice some new timber.

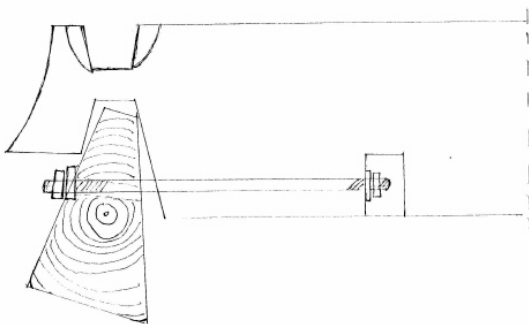
Sketch 2.2: Illustration of securing a pushed out sill with short *gjengestag*.

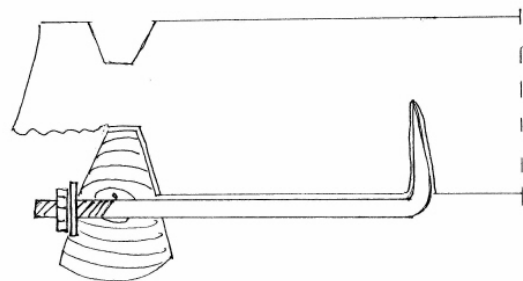
Sketch 2.3: Illustration of securing a pushed out sill with another form of short *gjengestag*.

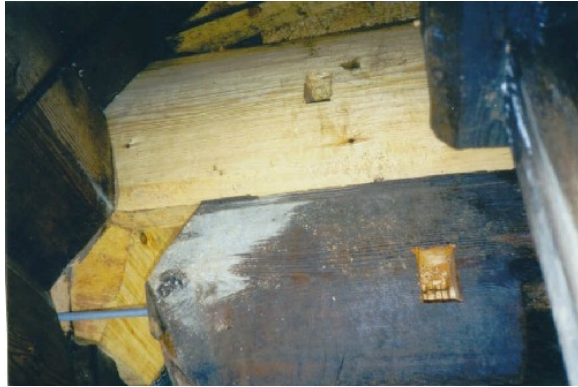
One can also use a *gjengestag* to repair the rot-damaged timber. Photo 2.3, Photo 2.4 and Sketch 2.4 show the method for repairing the crown end or cantilever that forms the support of an external hallway or balcony called a *svalegong* or *loptsvale*. The cantilever is called a *skakestokk*. Here the bar

is fixed to the original timber in the balcony while new and drilled-through timber is tightened onto it. As described above, the bar lies in the centre of the log and the nut is set into the timber. In addition, Photo 2.5 shows the installed cantilever after the balcony sills (*svalesydd*) are in place.

Photo 2.3: Using *gjengestag* to repair the cantilever (also called *skakestokk* and *overmann* and *undermann*) on a *loft* at Dale, Valle.

The repairs on the *loft* at Dale, Valle, were done in 2000/2001 by the owner (Photo 2.3, Photo 2.4, Photo 2.5 and Photo 2.9 on page 7) and was viewed as a lasting solution provided it is maintained properly. In particular it is important to avoid leaks in the roof. According to the laws and regulations this *loft* is eligible to be protected by resolution but it has not been automatically protected due to its age. The owner had financial support from the STILK fund, which offers grants for special initiatives for preserved and protected buildings in agricultural landscapes.

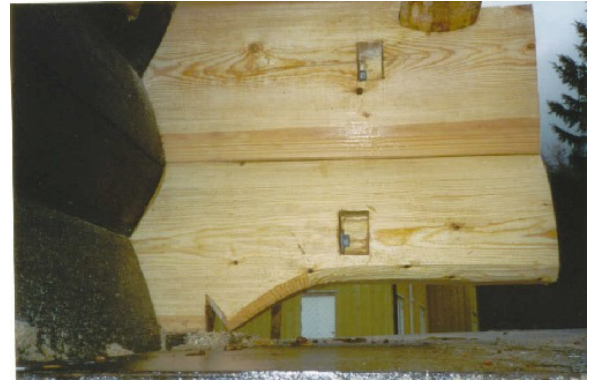
Photo 2.4: Installed cantilever on a *loft* at Dale, Valle.

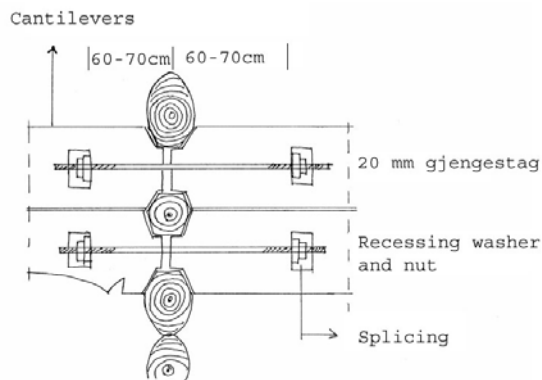
Sketch 2.4: Illustration of using *gjengestag* to repair a cantilever.

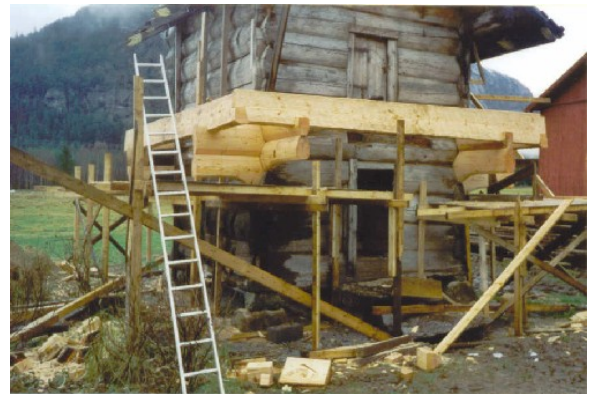
Photo 2.5: Everything installed with balcony sills (called *svalesydd* or *tilemor*) in place on a *loft* at Dale, Valle.

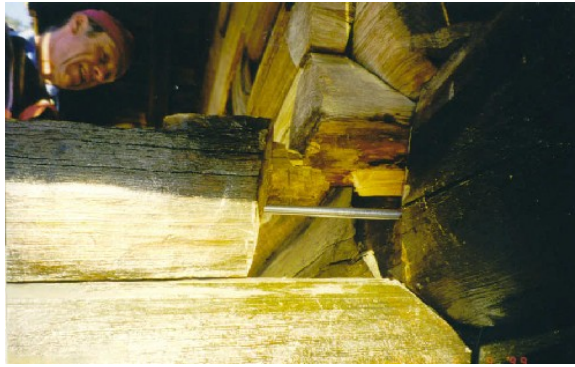
Photo 2.6 shows how a *gjengestag* is inserted through the log, and tightened together with nuts (Photo 2.7), and the final result at Bakken, Bjørgum (Photo 2.8). This can also be seen as an alternative to the solution presented later in chapter 2.5 - using bolts on Holslopte.

Photo 2.6: Repairing a damaged cantilever at Bakken, Bjørgum, Hylestad. The *gjengestag* is inserted into the beam.

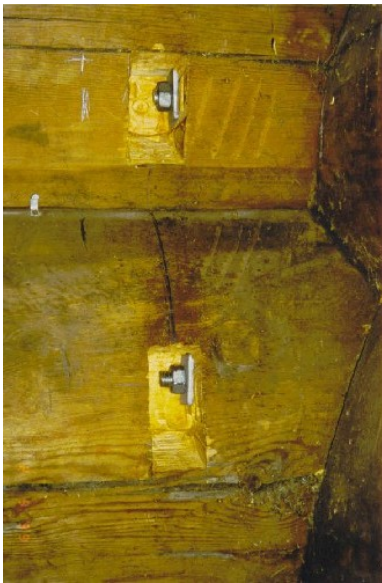
Photo 2.7: A *gjengestag* tightened together, Bakken, Bjørgum, Hylestad.

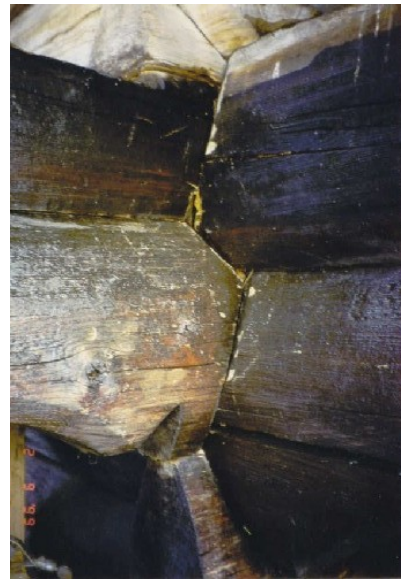
Photo 2.8: Finished repair at Bakken, Bjørgum, Hylestad.

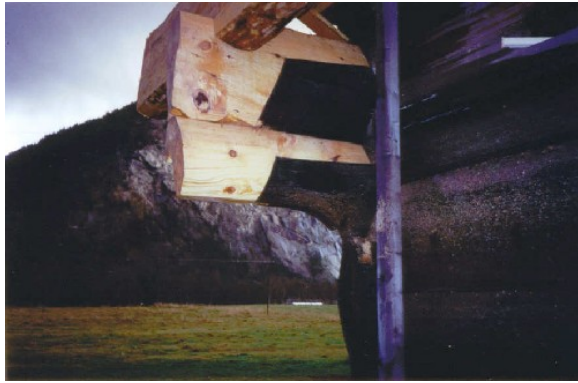
An alternative to using iron for repairing the cantilever is shown in Photo 2.9 using antiquarian methods. Sketch 2.5 shows how new timber is spliced onto the old timber using wooden rivets. To perform the work shown in Photo 2.3, Photo 2.4 and Photo 2.5 using an antiquarian method would require dismantling the roof and the top floor of the building to splice or replace larger parts of the timber. This would be necessary because of the extensive rot damage.

Photo 2.9: Rot-damaged cantilevers are spliced according to antiquarian methods on a *loft* at Dale, Valle.

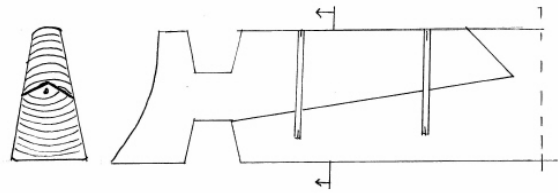
Sketch 2.5: Illustration of a spliced beam according to antiquarian methods.

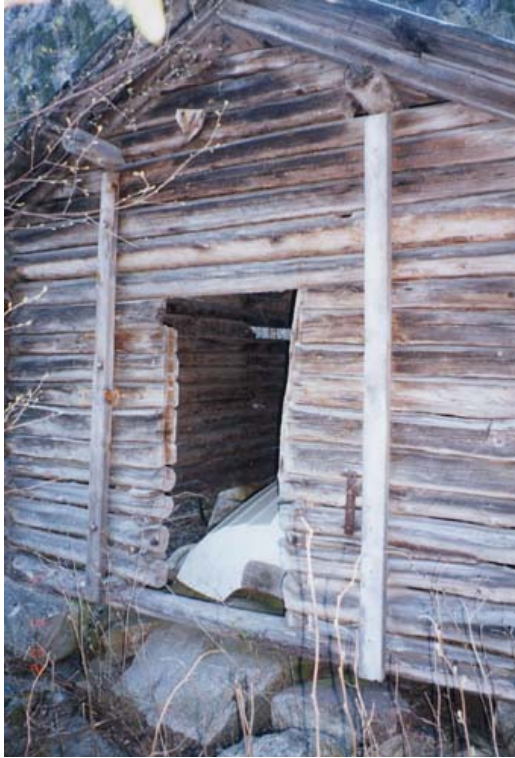
A single plank carriage consists of a board with long bolts drilled through the logs and tightened up. Photo 2.10 shows boards on the outside and Photo 2.11 shows bolts on the outside. A double plank carriage has two boards, for example both inside and outside, drilled through the timber and tightened up with bolts. By using a double plank carriage one can sometimes avoid drilling through original timber, provided the logs have not settled on top of each other (this settling is often referred to as *su* or *medrag*). This is shown in Photo 2.12 as seen from the outside and in Photo 2.13 as seen from the inside. This iron solution used at Bakken in Bjørgum Hylestad is illustrated in Sketch 2.6. Photo 2.13 from the animal shed at Systog, Løyland with the use of plank carriage on a shed that is still in use. And Photo 2.14 shows how plank carriages are used on the main house at Henriksentunet, Bykle. Finally, Photo 2.15 shows a plank carriage used inside and in the corner of the *loft* at Austad, Bygland.

Photo 2.10: Interior and exterior plank carriage seen from the outside on the hut at Flåstrondi.

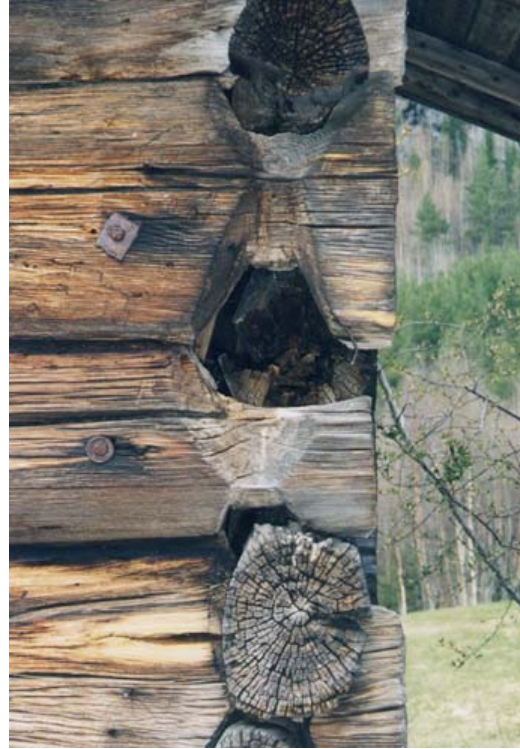
Photo 2.11: External plank carriage seen from the outside on the *loft* at Flateland.

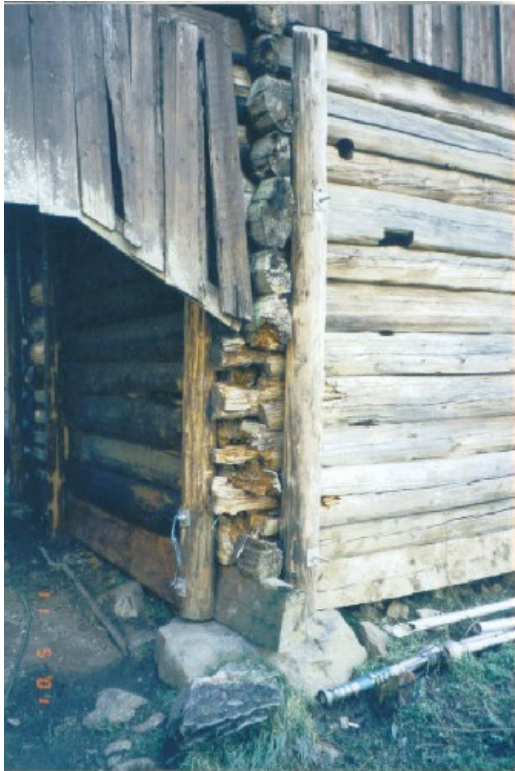
Photo 2.12: Double plank carriage seen from the outside on the barn at Bakken, Bjørgum.

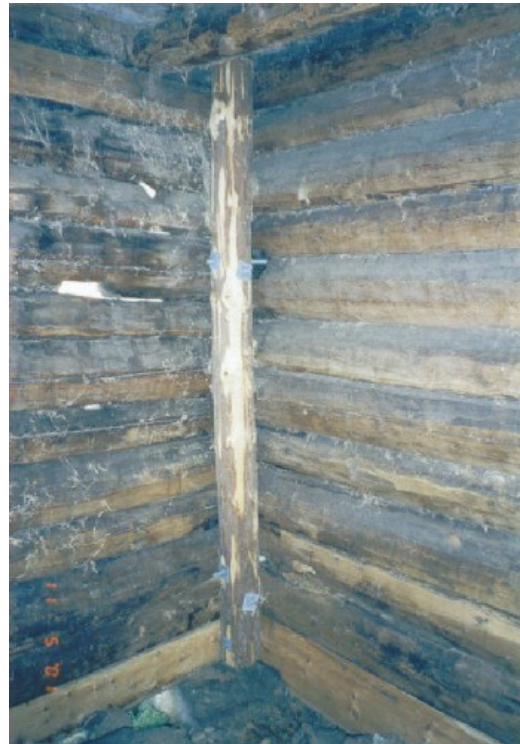
Photo 2.13: Double plank carriage seen from the inside on the barn at Bakken, Bjørgum.

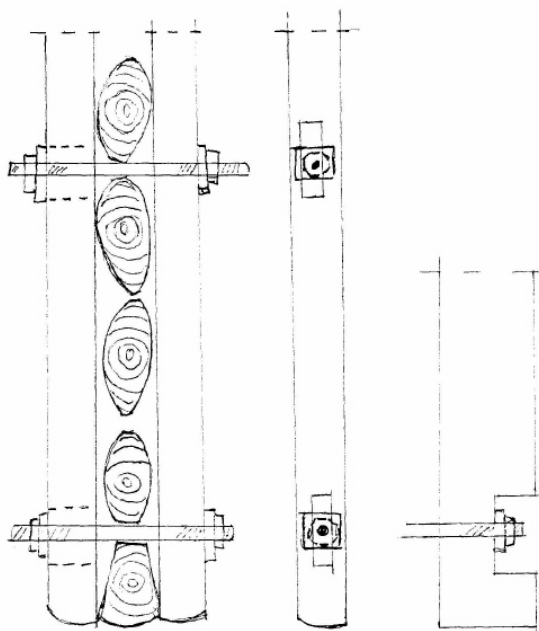
Sketch 2.6: Illustration of a double plank carriage on the barn at Bakken, Bjørgum.

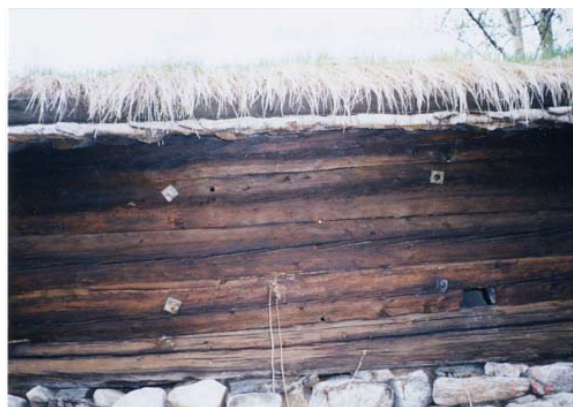
Photo 2.14: Plank carriage at Henriksentunet, Bykle.

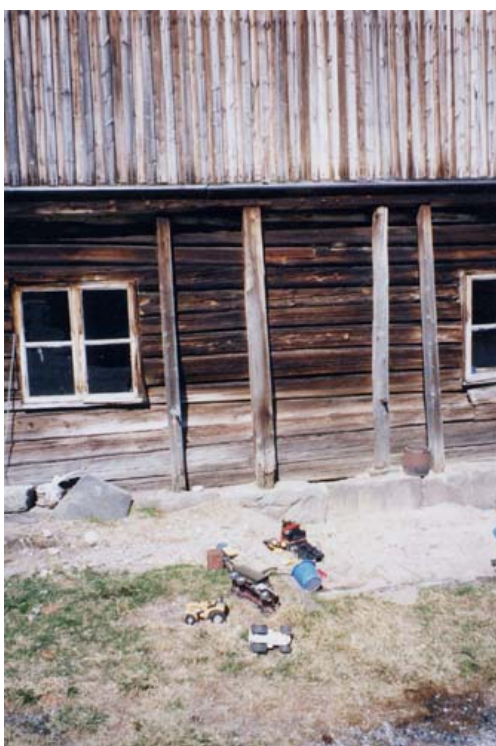
Photo 2.13: Plank carriage on an animal shed, Systog, Løyland, Valle.

Good craftsmanship is necessary to make the plank carriage a viable alternative. For example, were bolts often found to corrode quickly in the damp and variable temperatures of animal sheds (see for example the animal shed in Photo 2.13 on page 11). One should account for this by recessing the nut into the log and splice the hole with new material (see illustration in Sketch 2.6 on page 11). In addition, it is important to allow the building to settle without letting it rest on the plank carriage. As is also illustrated in Sketch 2.6, this is done by cutting a rectangular and vertical slit in the plank carriage board, behind the washer and nut, to give the bolt that is inserted through the slit room to slide as the wall settles.

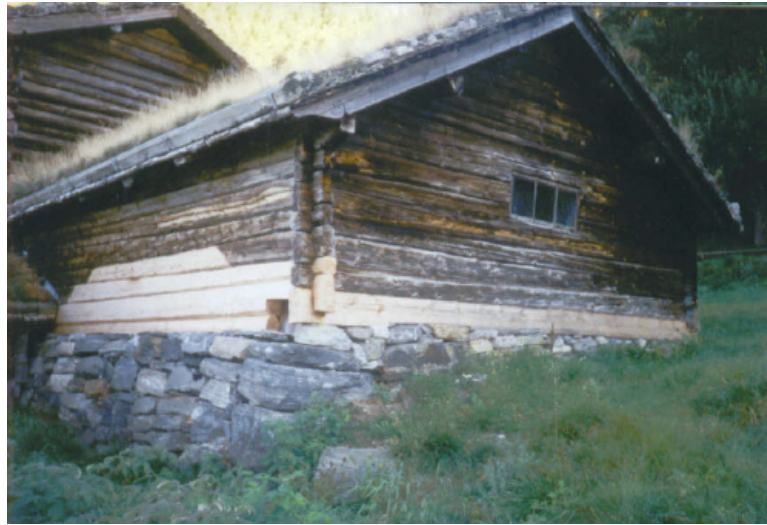
At one stage it was considered using plank carriages on the animal shed at Rygnestadtunet, however the rot damage was too substantial. As such, the restoration work was performed according to antiquarian methods. Some material was spliced and logs and beams were replaced. Photo 2.16 shows the finished shed. See also the

Photo 2.16: Antiquarian methods were used to restore the animal shed at Rygnestadtunet.

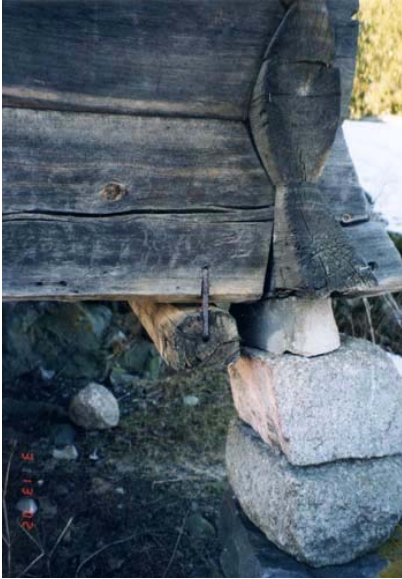
Photo 2.17: Log dogs are used to secure a sill to the beam above, *loft*, Tveitetunet, Valle.

As discussed before, the log dog is not an iron solution used frequently on log houses. It is mainly used to secure buildings against collapsing foundations and wind damage. In spite of the desire to use antiquarian methods, two log dogs were used to restore the *loft* Brottveitslopte (see chapter 2.3). This iron solution came to about 5.000 kroner. The alternative would have included dismantling or jacking up the roof to insert two new wall tie logs (*skorbitar*). This process would cost about 100.000 kroner. The two log dogs were hardly visible because they were installed inside the building and the original timber was retained. As in the example of securing the *loft* and main house at Tveitetunet (see Photo 2.17 and Photo 2.18 on page 13) using a log dog is a lasting and stable solution.

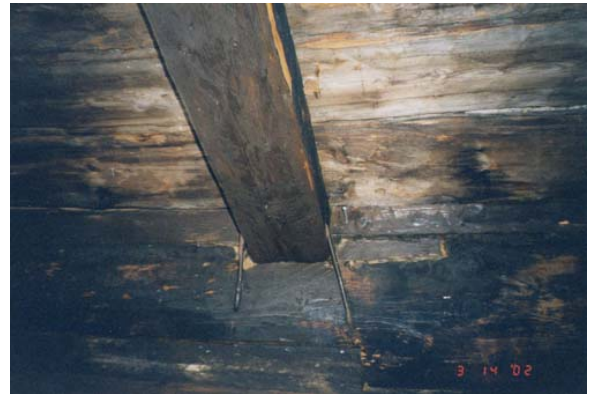
Photo 2.18: Log dogs are used to secure the rafters to the plate log (called *stavlegja* or *raptstokken*) for stability against the wind, Tveitetunet, Valle.

Photo 2.18 shows how rafters on the first floor (called *skjeltile*) are secured to the plate log (called *stavlegja* or *raptstokken*). This is unusual because one normally did not secure buildings with turf roofs against the wind.

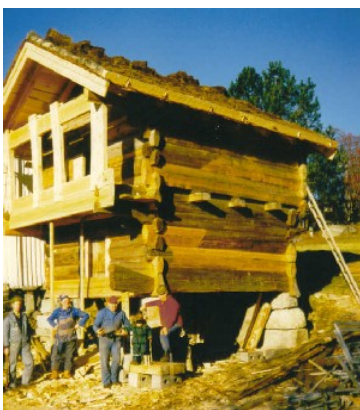
Log dogs are normally found on light framework buildings, particularly to secure the roofs against wind damage. For example, the Brottveitslopte was restored in 1995 using antiquarian methods (see Photo 2.19). This *loft* has a rafter roof without purlins (called *åsar*). The plate logs that carry a pure rafter roof with birch bark and turf are under a lot of strain, particularly under large amounts of snow. The plate logs were restored but the wall tie log (called *skorbiten*) was very weak. To secure the plate log against being pushed out under the weight of the roof it was decided to install two interior log dogs, one at each corner (see Sketch 2.7).

Photo 2.19: The *loft* Brottveitslopte restored according to antiquarian methods, Valle.

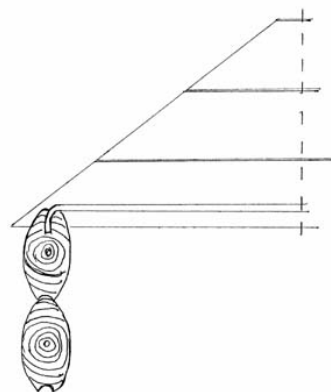
Sketch 2.7: Illustration of a log dog.

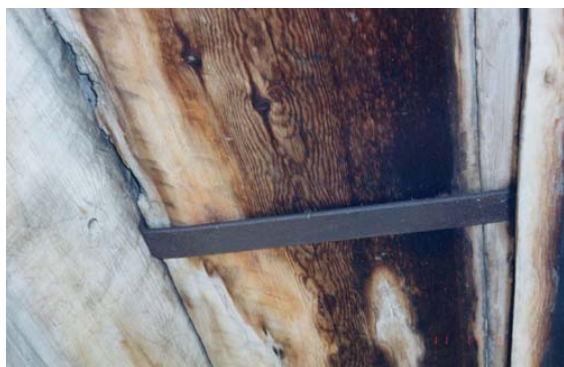
In the 1920s-30s the floorboards on the balcony at Rygnestadlopte were secured with an iron binding (called a *jernklave*) to avoid sagging (see Photo 2.20). There is a large span between the cantilevers and these were in danger of breaking. The same was found on Muggslopte in 1999. Iron bindings were used both to strengthen floorboards (Photo 2.21 and Photo 2.22) and to secure cracked and rotten legs (see Photo 2.23). In this latter solution the photo shows that some legs were also restored and re-used.

Photo 2.20: Securing floorboards on the balcony at Rygnestadtunet, Valle.

Rygnestadlopte is protected by resolution (see Table 1 on page 39). The cost of the iron binding shown at Rygnestadtunet was around 2.000 kroner, while an antiquarian method would have cost around 5.000 kroner. The latter method would include replacing the floorboards and losing original timber, while the iron solution would look aesthetically different because the iron binding is relatively visible. The third example used in chapter 2.4 was securing and re-using the leg on the *loft* Muggslopte. The cost was 2.000 kroner compared to an antiquarian solution of 6.000 kroner given that a new leg would have to be constructed (Photo 2.23 on page 14 shows both a secured leg and one reconstructed). In both examples it is therefore necessary to compare the costs as well as the aesthetic value (visible iron bindings) and the loss of original timber with the antiquarian methods. Photo 3.2 shows the *loft* Muggslopte.

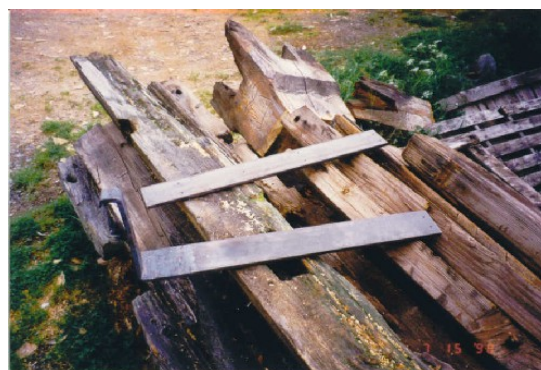
Photo 2.22: Iron binding used on Muggslopte, at Innestog, Byklum, Bykle.

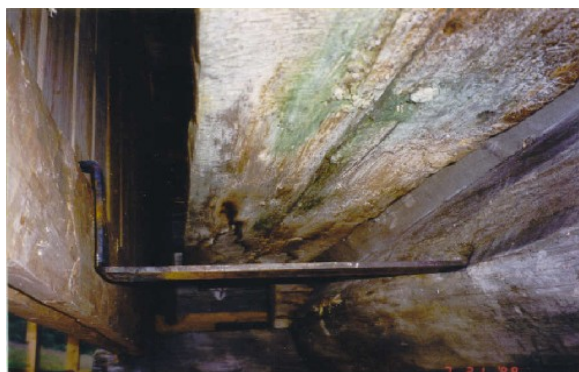
Photo 2.21: Iron binding used on Muggslopte, at Innestog, Byklum, Bykle.

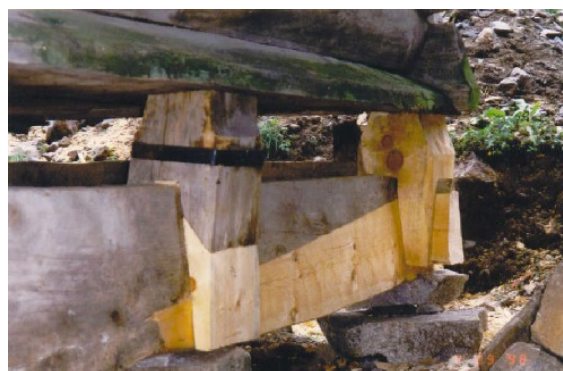
Photo 2.23: Securing a damaged leg to re-use it with the help of an iron binding on Muggslopte, at Innestog, Byklum, Bykle. See the new and replaced leg in the background.

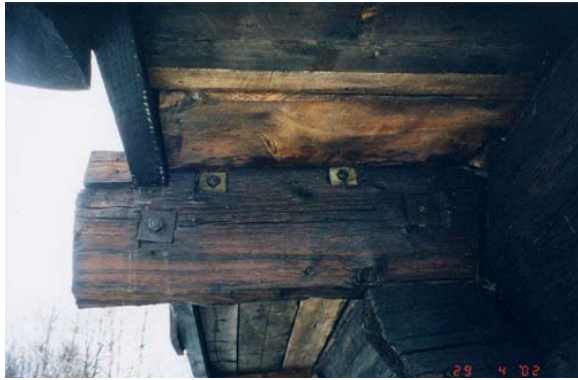
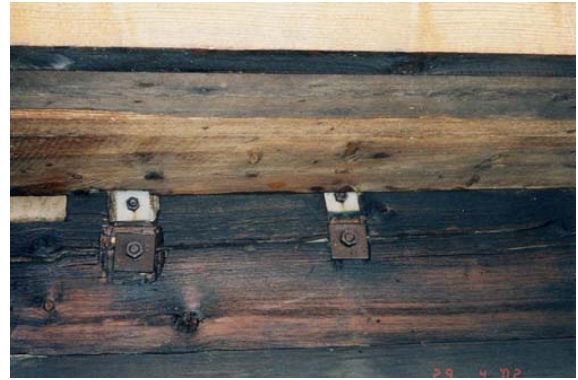
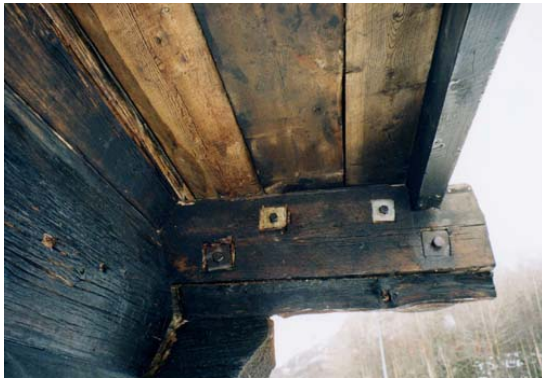
Bolts are used to strengthen and secure beams and posts against decay. It involves drilling through original timber and tightening it up with a long bolt and washer at either end (shown in the photos below).

Photo 2.24: Strengthening of a rot-damaged cantilever on the balcony at Holslopte, Bykle.

Photo 2.26: Strengthening of a rot-damaged cantilever on the balcony at Holslopte, Bykle.

Photo 2.25: Strengthening of a rot-damaged cantilever on the balcony at Holslopte, Bykle.

The *loft* Holslopte in Bykle was dismantled and moved in the 1970s due to the development of hydroelectricity in the area. When the *loft* was rebuilt the cantilever was strengthened with bolts (see Photo 2.24, Photo 2.25 and Photo 2.26). Another alternative would have been to splice with new material according to the antiquarian method or by using a *gjengestag* (iron bar) as presented in chapter 2.1.

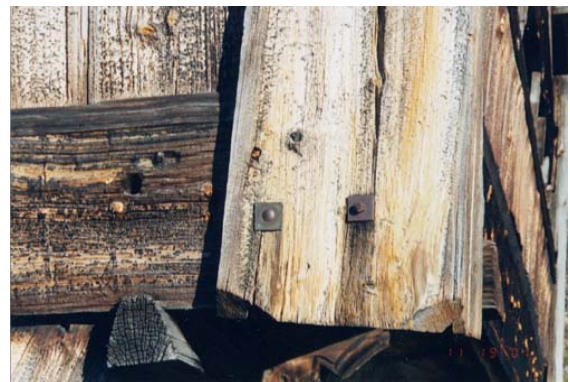
Photo 2.27: Securing a corner post on the balcony at Rygnestadtunet, Valle.

Bolts were also used on Rygnestadlopte in the 1920s-30s to strengthen the corner post and secure it against further damage (see Photo 2.27).

The corner post on the *loft* Rygnestadlopte that was secured with bolts in the 1920s-30s has a high historical value and dates back to the 1580s-90s. Using antiquarian methods parts of the timber would have to be replaced making this solution less reversible than to drill holes for the bolts. The building protection work on the *loft* Holslopte was performed because it is a magnificent building and an example of good craftsmanship. From an antiquarian viewpoint Holslopte and Rygnestadlopte are equally valuable. However, Rygnestadlopte ranks higher because it is still standing on its original foundations while Holslopte had been moved due to the hydroelectric development project in the area.

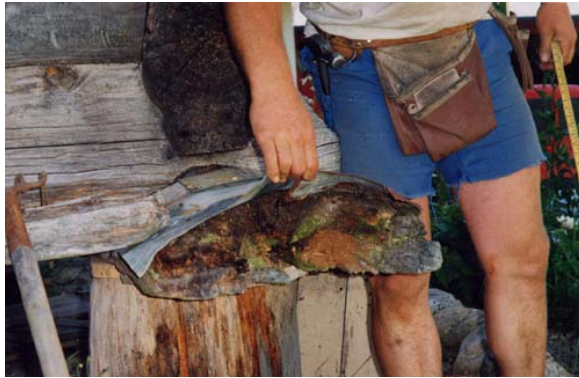
As seen in Photo 2.28 the protruding sills on the house at Helle, Hylestad, have been covered with lead panels. Substantial rot damage was already found and the iron solution was used to protect the building pending future restoration. For the same reason, this solution was used on the emerging rot damage on beams on a hut at Henriksentunet in

Photo 2.28: Covering up rot damage with lead panels on the house at Helle, Hylestad.

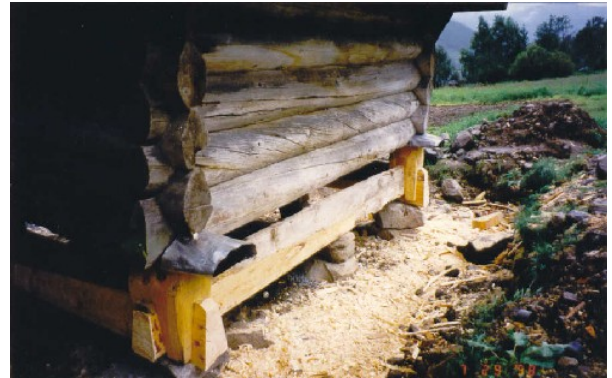
Photo 2.30: Protruding parts are covered with lead panels on Muggslopte, Innestog Byklum, Bykle.

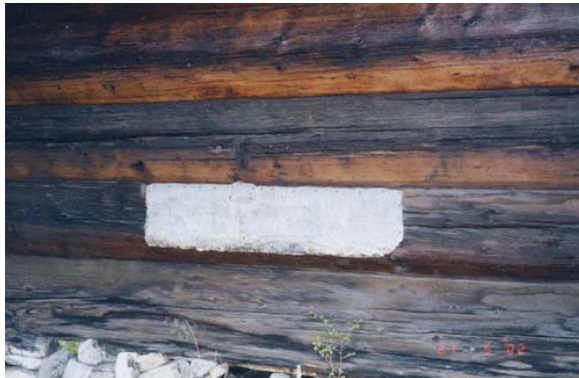
Photo 2.29: Covering up rot damage with lead panels on the hut at Henriksentunet, Bykle.

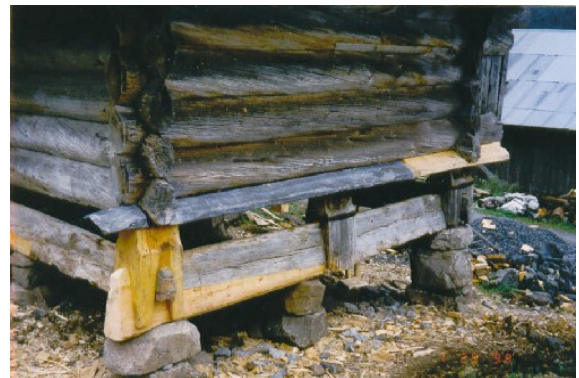
Photo 2.31: Using lead panels to secure the original sill on Muggslopte, Innestog Byklum, Bykle.

Similarly there is no antiquarian alternative to using lead panels to cover existing rot damage without splicing and replacing original timber. The purpose is to cover up the damages at relatively low costs (around 3.000 kroner) until further work can be done (see Photo 2.31 on page 16 for the solution on Muggslopte).

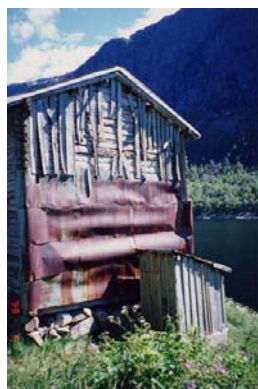
When larger parts of a building are rot-damaged and weathered one can also use lead panels as cover - until full restoration is possible. This is shown in Photo 2.32 where the barns at Brotteli and Helle were visibly rot-damaged in the 1930s-40s.

Photo 2.32: Covering rot damage with lead panels, barns at Brotteli, Bykle and Helle, Hylestad.

The problem arises when a temporary solution becomes a lasting one or because it takes too long before complete restoration is done. This was the case on the barn at Brotteli (see Photo 2.32 on page 16) where it is now time to do the full restoration. If this is not done soon the barn cannot be repaired. The decision is guided by the high cost of complete restoration. Even if the iron solutions that were used on this building during the 1940s-50s now look aesthetically bad, this was one of the few options they at the time because of limited private funds.

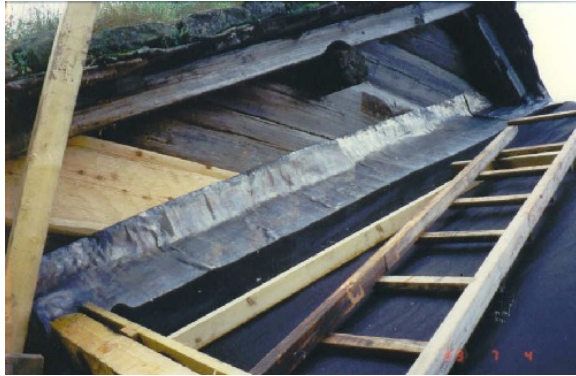
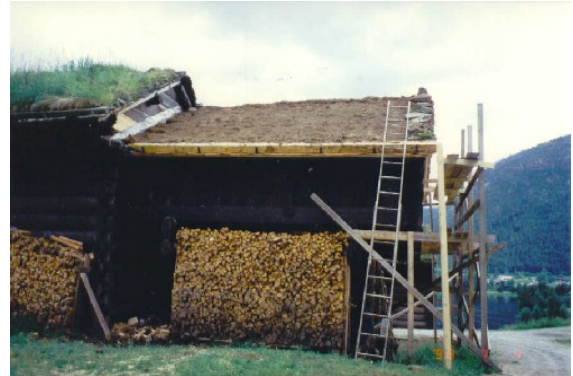
The above examples are clearly temporary solutions. On the other hand, Photo 2.33 and Photo 2.34 show how, in 1999, lead panels were used to avoid future rot damage on the roof where turf normally touches the timber. This is a lasting solution.

Photo 2.33: Using lead panels to protect the surface between roof/turf and timber at Bakken, Bjørgum, Hylestad.

Photo 2.34: Using lead panels to protect the surface between roof/turf and timber at Bakken, Bjørgum, Hylestad.

While most of the iron work using lead panels are temporary solutions until one can perform complete restoration, it is also possible to use lead panels as preventative measures as was done at Bakken, Bjørgum (see Photo 2.33 and Photo 2.34 on page 17). The costs were covered with both private and public funds (STILK) and were around 3.000 kroner. There is no comparable antiquarian alternative to using lead panels because timber cannot help prevent rot damage. The solution also has little negative effect on the aesthetics of the building because birch bark and turf cover most of the lead.

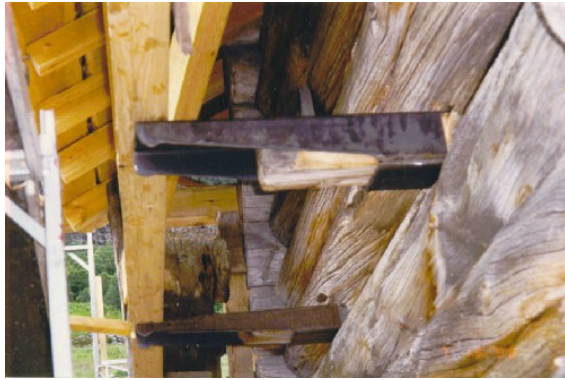
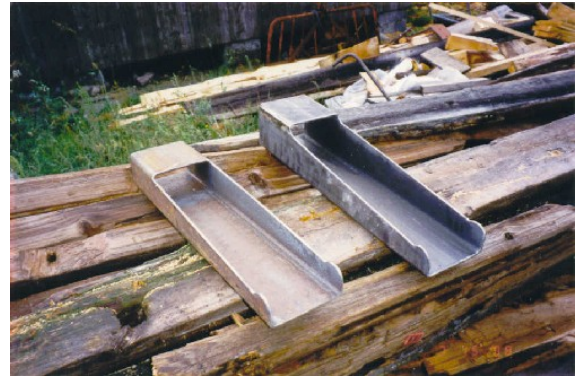
A beam extension or *bjelkeforlenging* can be used to secure balconies against collapse. Photo 2.35 (and Photo 2.36) show the effect of damage to Muggslopte in Bykle after years of weathering and rot damage. The extensive damage had occurred mainly because the balcony was left open without wall panelling. The iron solution extends the cantilevers such that the balcony sill can rest on them. Afterwards one lays the floorboards on the iron extensions so one can walk around the balcony. Alternatively, with antiquarian methods, one would dismantle the roof and the top floor of the *loft*. New beams would have to be constructed because it would not be sufficient to use splicing.

Photo 2.35: Securing the foundation in the balcony by extending the beams, Muggslopte, Innestog Byklum, Bykle.

Photo 2.36: Iron used to extend the beams, Muggslopte, Innestog Byklum, Bykle.

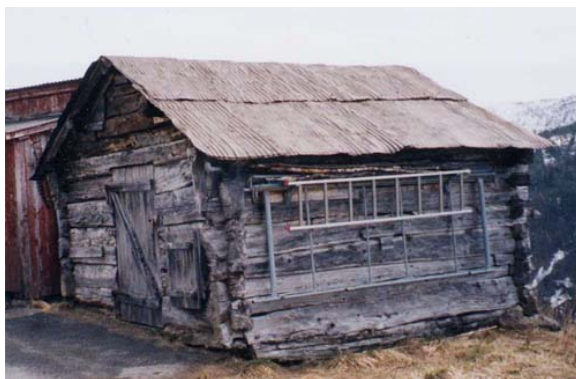
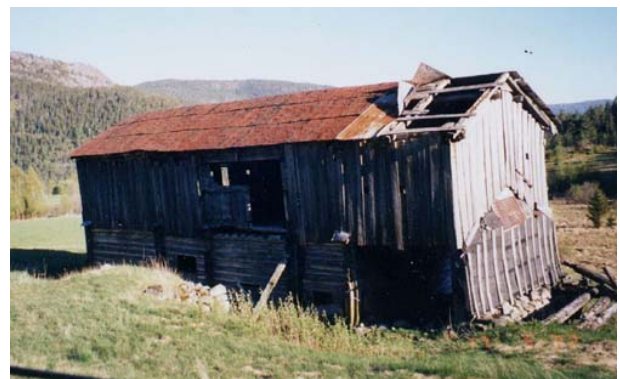
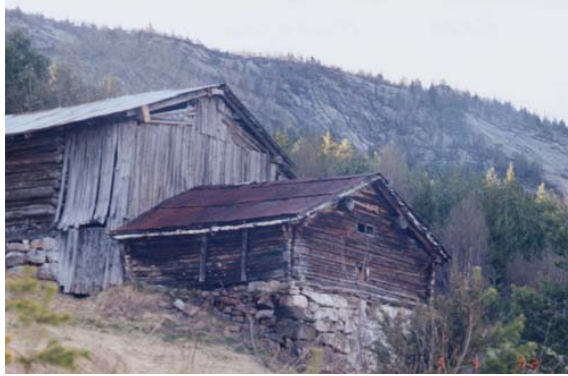
Photo 2.37, Photo 2.38 and Photo 2.39 show how pitch panels were used in the 1940s for roofing on huts, barn and animal sheds.

Photo 2.37: Pitch panels on a hut at Jåro, Bykle.

Photo 2.38: Pitch panels on a barn at Uppstad, Hylestad.

Photo 2.39: Pitch panels on an animal shed at Berg, Hylestad.

Pitch panels, also called "poverty panels", show solutions from an era with few resources and no public funds to support building protection. Many buildings are still covered with pitch panels because the panels are relatively durable even if they are corroded. In other words, the pitch has helped reduce corrosion damages to the building.

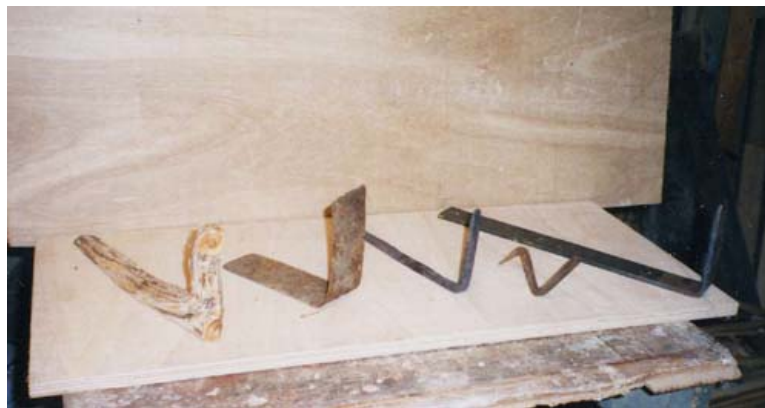
During times with few available resources it was often necessary to re-use pitch barrels as pitch panels. A similar situation often occurred when materials were re-use for turf board hooks. These hooks are called *kroknev* and are used to support the board that again holds the roof turf in place. Photo 2.40 shows the development of hooks. Originally they used juniper, afterwards they re-used horseshoes and other iron products. Finally hand-made *kroknev* were used when people had the means to buy iron. The hook furthest to the right in the photo is modern and made from galvanized iron.

Photo 2.40: Different materials used for turf board hooks through the ages.

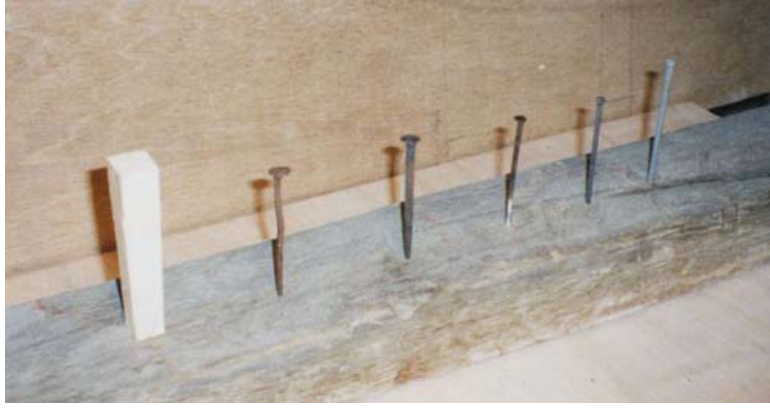
Photo 2.41: Different materials used to make nails.

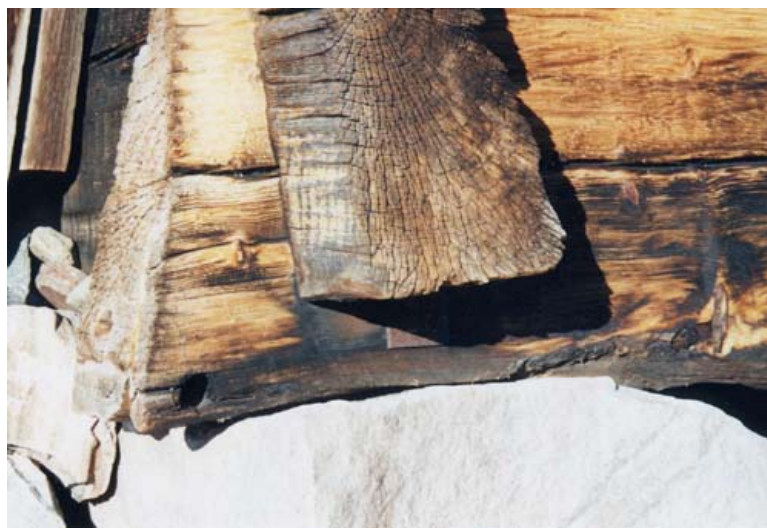
Photo 3.1: Securing a pushed-out sill at Rygnestadtunet, Valle.

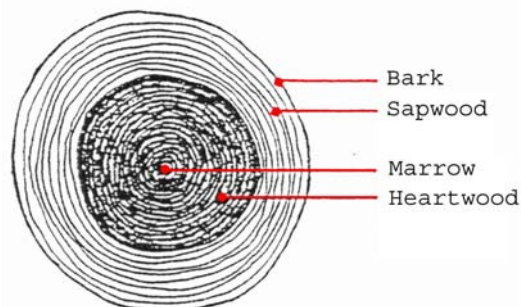
With antiquarian splicing it is important to use timber of excellent quality - normally heartwood (called *malmvirke*). Sketch 3.1 shows a cross section of a pine tree. The outermost part is called sapwood (*geiteved*, *ytved* or *flaskved*), the light brown part from the marrow to the sapwood is the heartwood (*malmved*, *kjerneved* or *al*), this part is particularly durable against rot.

Sketch 3.1: Cross section of a pine tree.

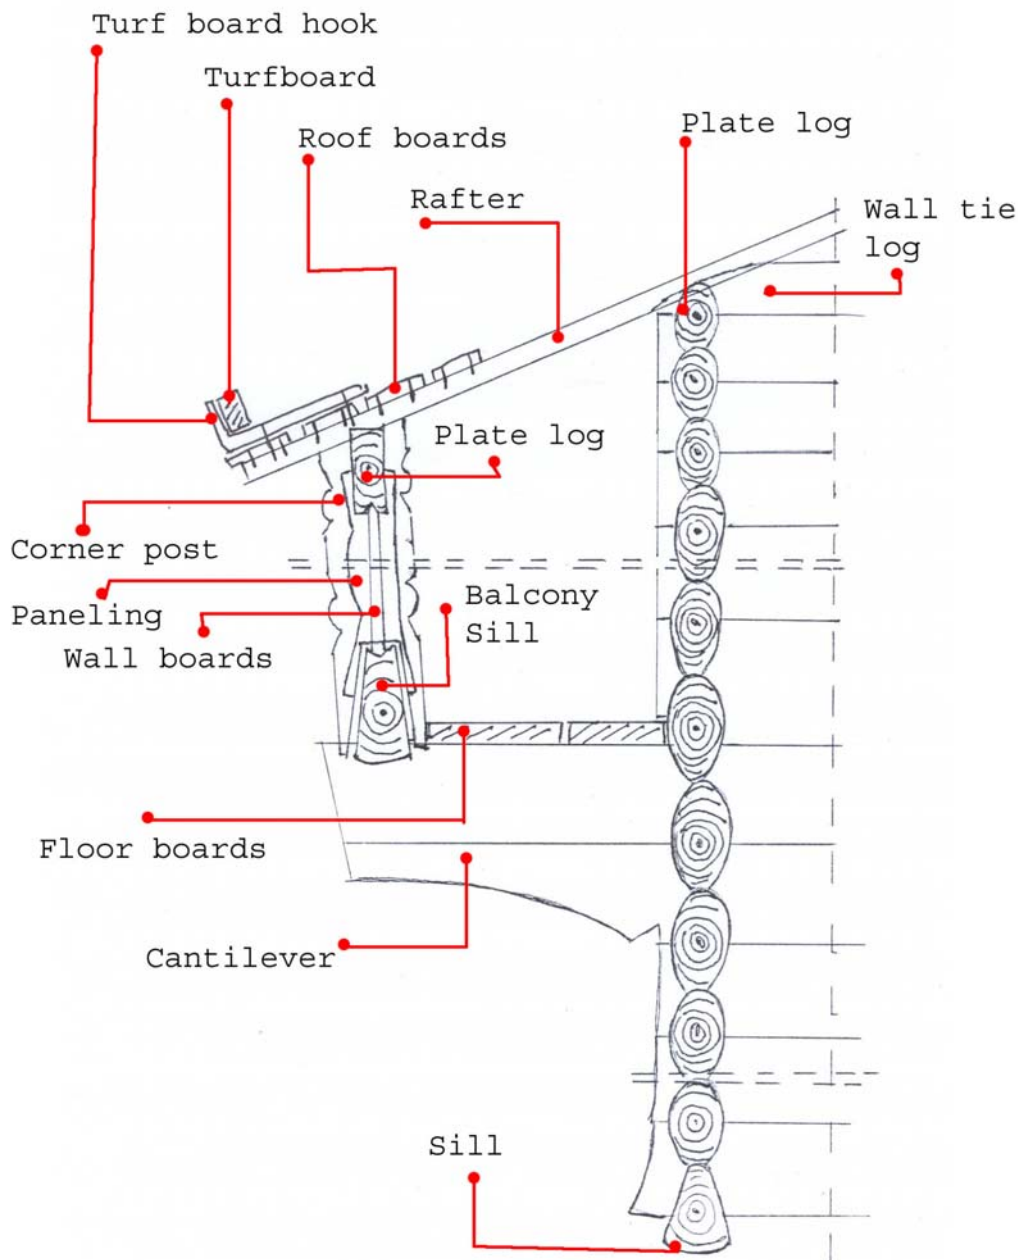
Sketch B2.1: Illustration with explanation for use of words on the cross section of a *loft*.
